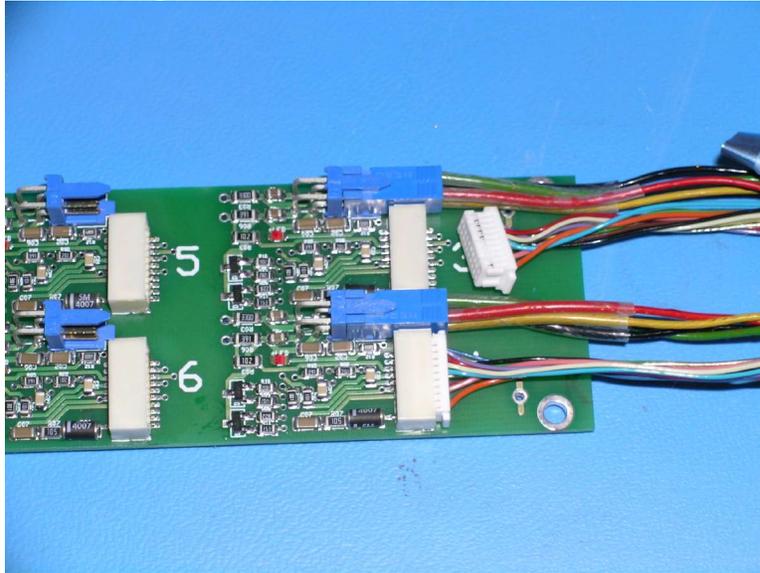
1. Electrical tests very fine for all: continuity of lines and isolation to neighbours.
2. 2 splices at limit length
3. 8 out of 10 splices thicker than specified. Is it a problem ?.
4. Strip back length:
 - One is smaller than specified (72.5mm) (cable 00003)

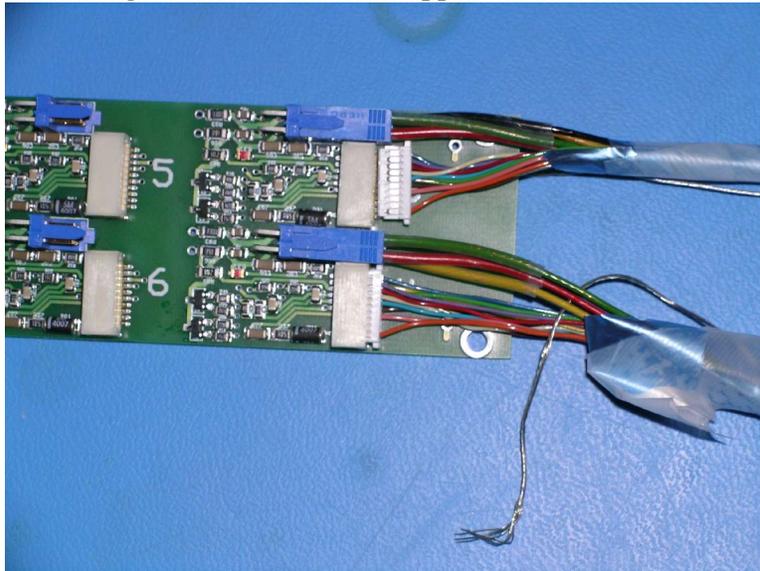
- Even if the specification is achieved, the difference in length between the 2 connectors can be greater than 2mm. It happens n 3 cables (00002, 00004, 00005).

In 00002, it looks like the dark blue wire is shorter than the rest (rework?) , making the length on this connector shorter. Idem for yellow wire in 00004.

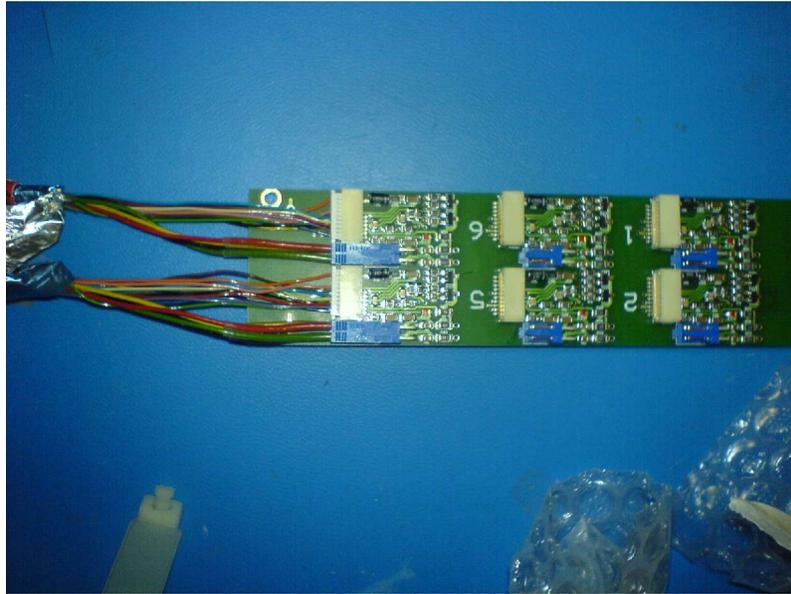
- If I look at the cables connected to PPB1, I don't understand why this 2mm difference, the edge of both connectors are at the same level (maybe because of the expected routing?):
