X-Ray Inspection of Flip Chip Assemblies

K. Einsweiler, M. Gilchriese and J. Richardson
LBNL

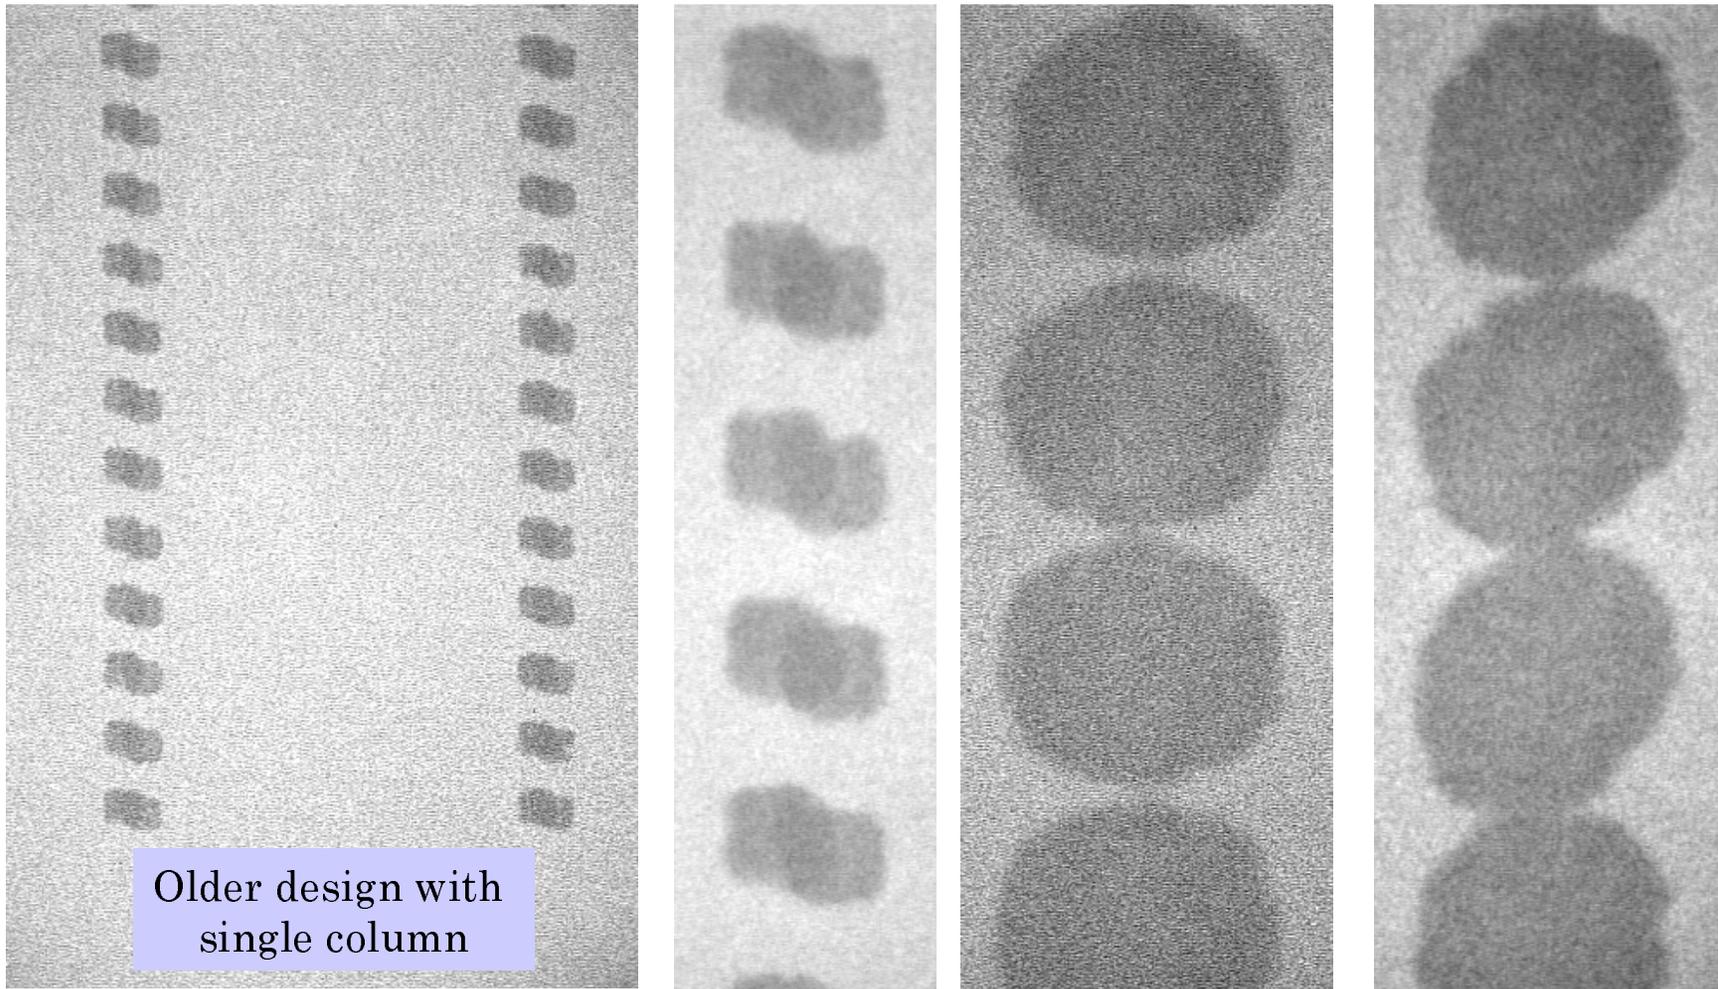
Boeing Indium Bump Dummy 16-Chip Module

Region of poor registration

Nearly merged

Merged bumps

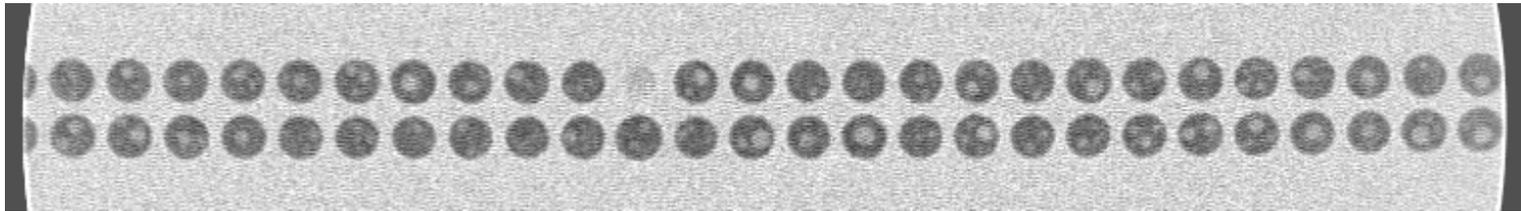
Region with missing bump

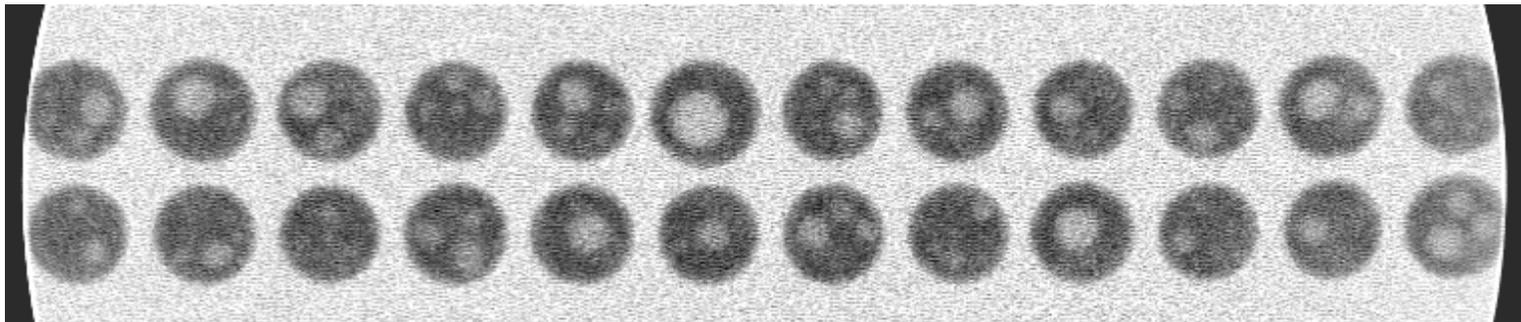
Higher magnification - notice voids

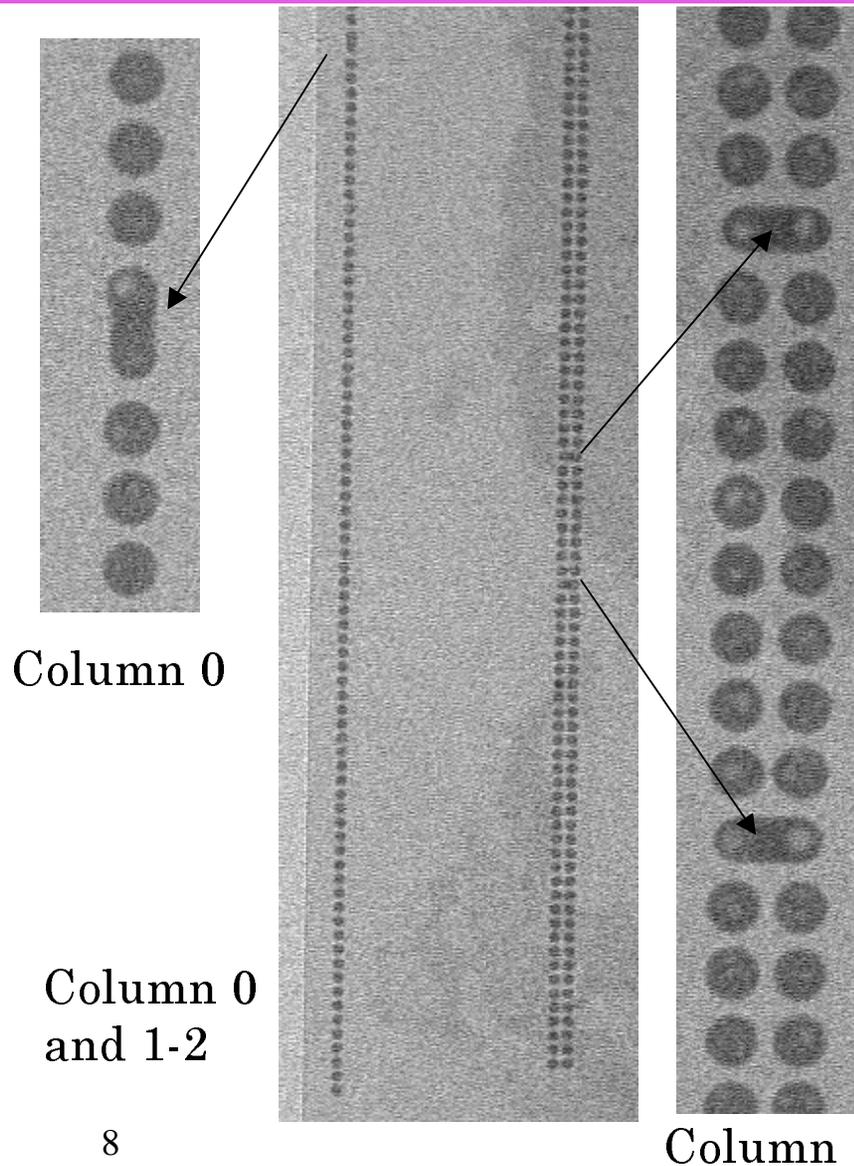
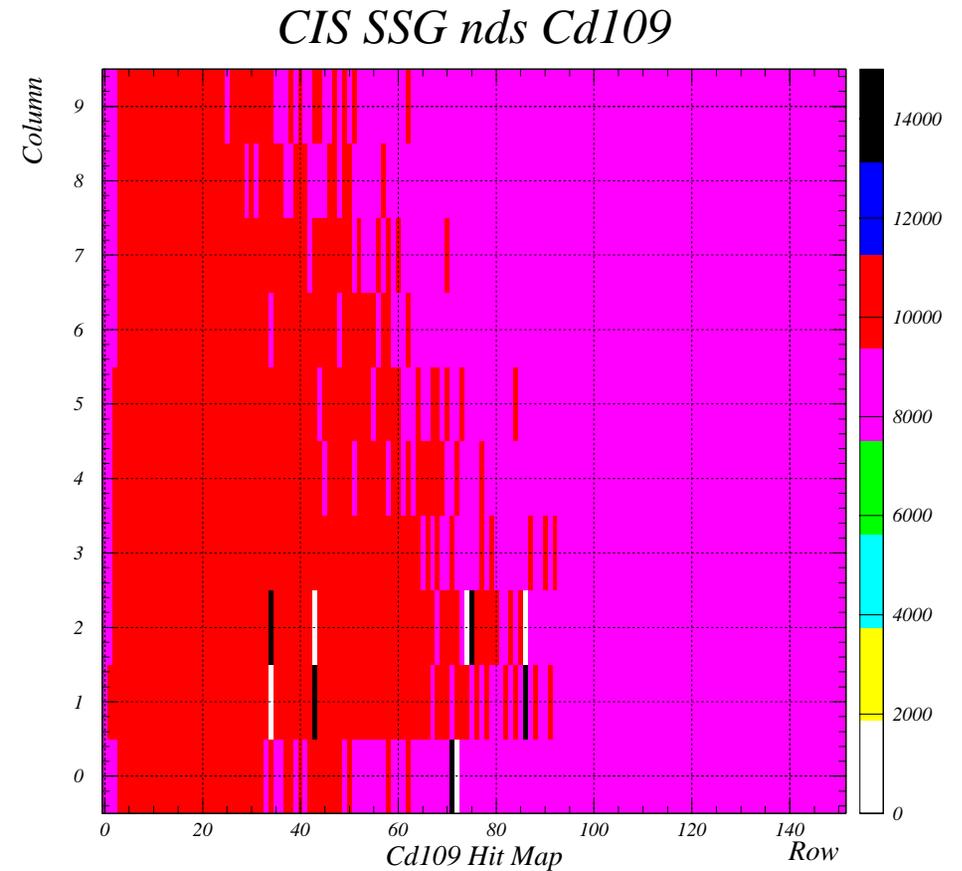
Active Devices - SSG(Solder Bumps)

Complete correlation between pairs of dead and double rate channels with bridged bumps

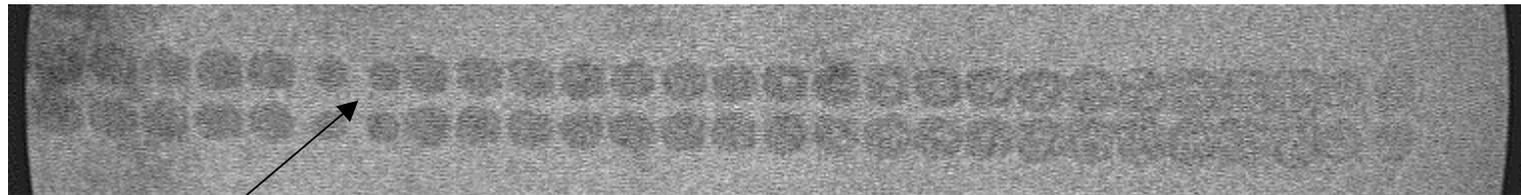
Columns 1-2
Rows near 0

Unattached
region

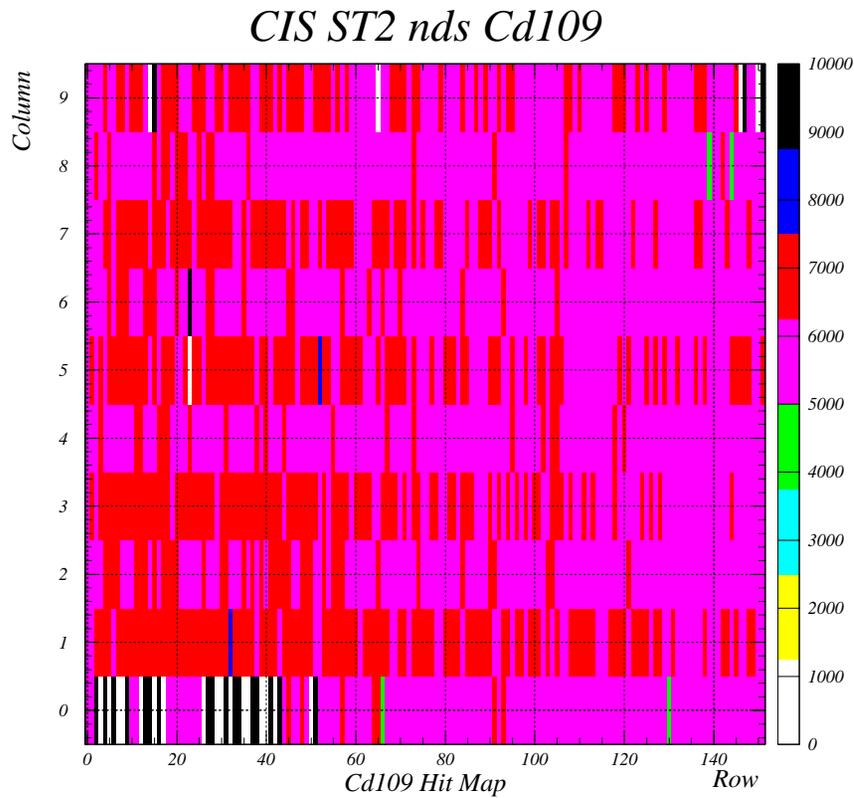
Merged bumps in column 0

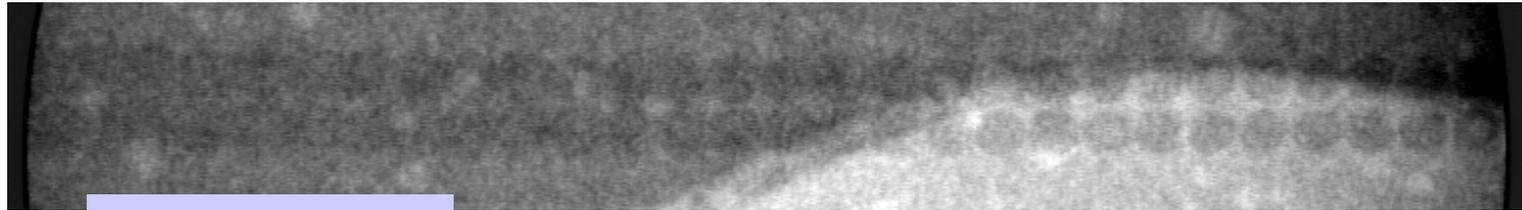
CDS62
columns 7- 8

Merged bumps

- Two diamond assemblies - CDS61 and CDS62
- Both show same feature of region of merged bumps near center of die.
- Diamond not flat - local region. Need to measure flatness before bumping.
- There was some indication of this already from person doing original lithography for photoresist.
- However, this does not readily explain why most(almost all) of channels are not responding. Most of bumps look OK away from center.

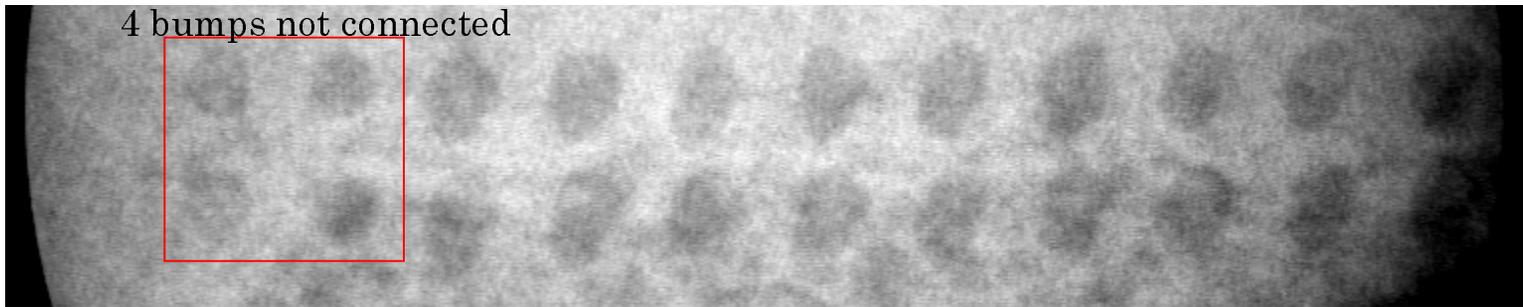
Column 5-6
Near row 0
"Dead" region
Misregistered?

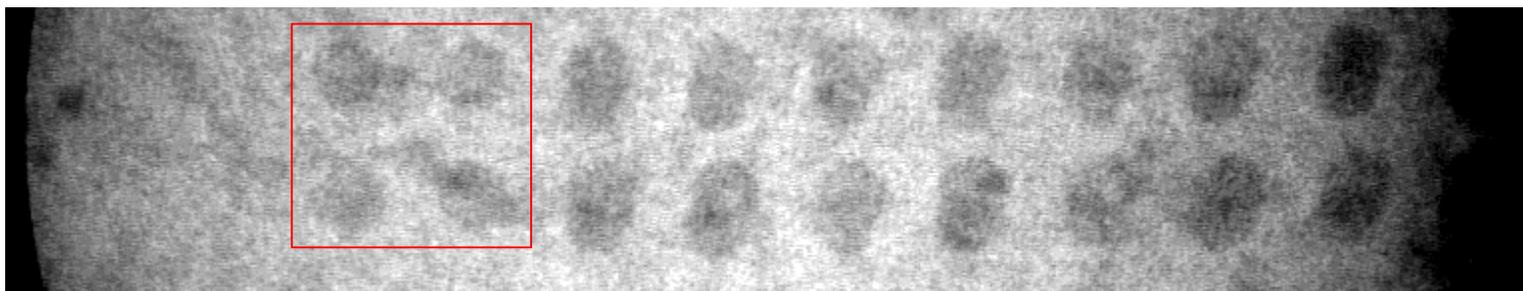
Column 7-8
Near row 0
"Dead" region
Misregistered?

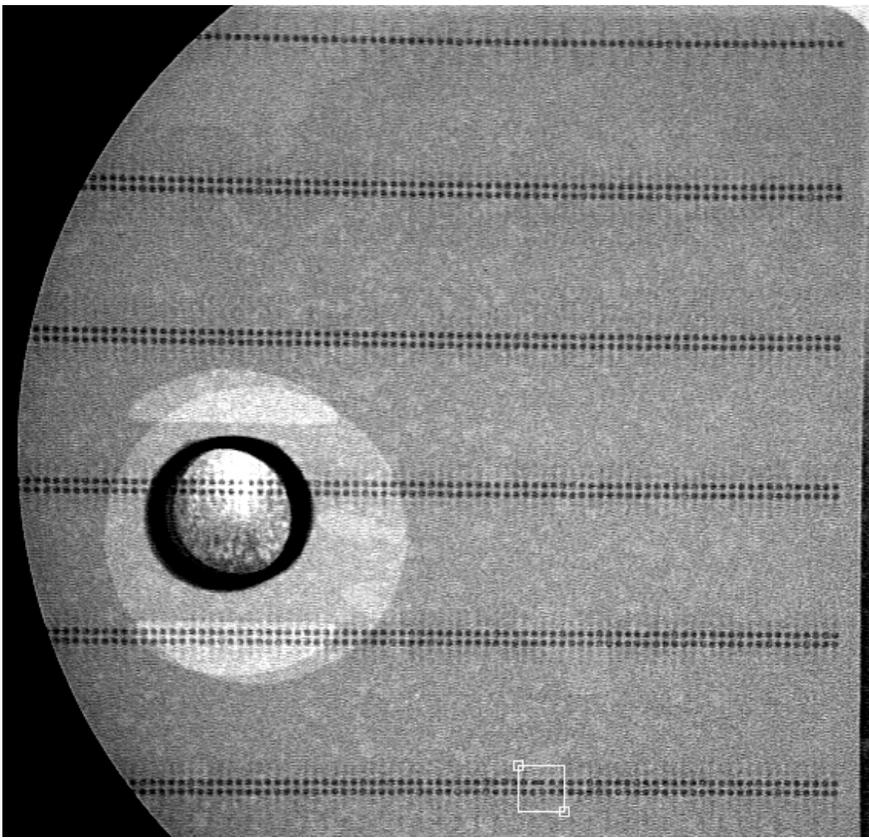
- ST1 and ST2 assemblies.
- Missing bumps and bridged bumps observed - need to be correlated with source scan. Bridged bump seen correlated with dead channel in calibration,

ST1 - note bridge bump in column 9

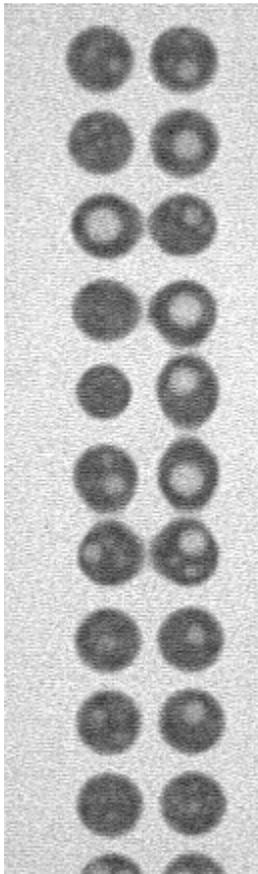
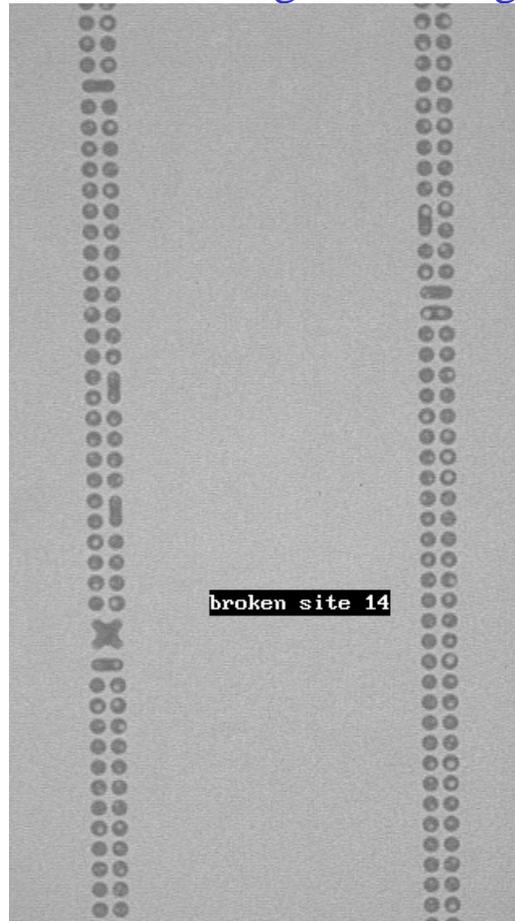
- Looked at module broken during shipment and undamaged module. Both are bare.
- Scanned for bridges and missing. May miss some bridges(see 1st picture). Able to scan with module in gelpak.
- Assuming defects = 2*bridged+missing, rate is 1-2%.
